The Fukushima Daiichi Incident

Matthias Braun PEPA4-G, AREVA–NP GmbH Matthias.Braun@AREVA.com

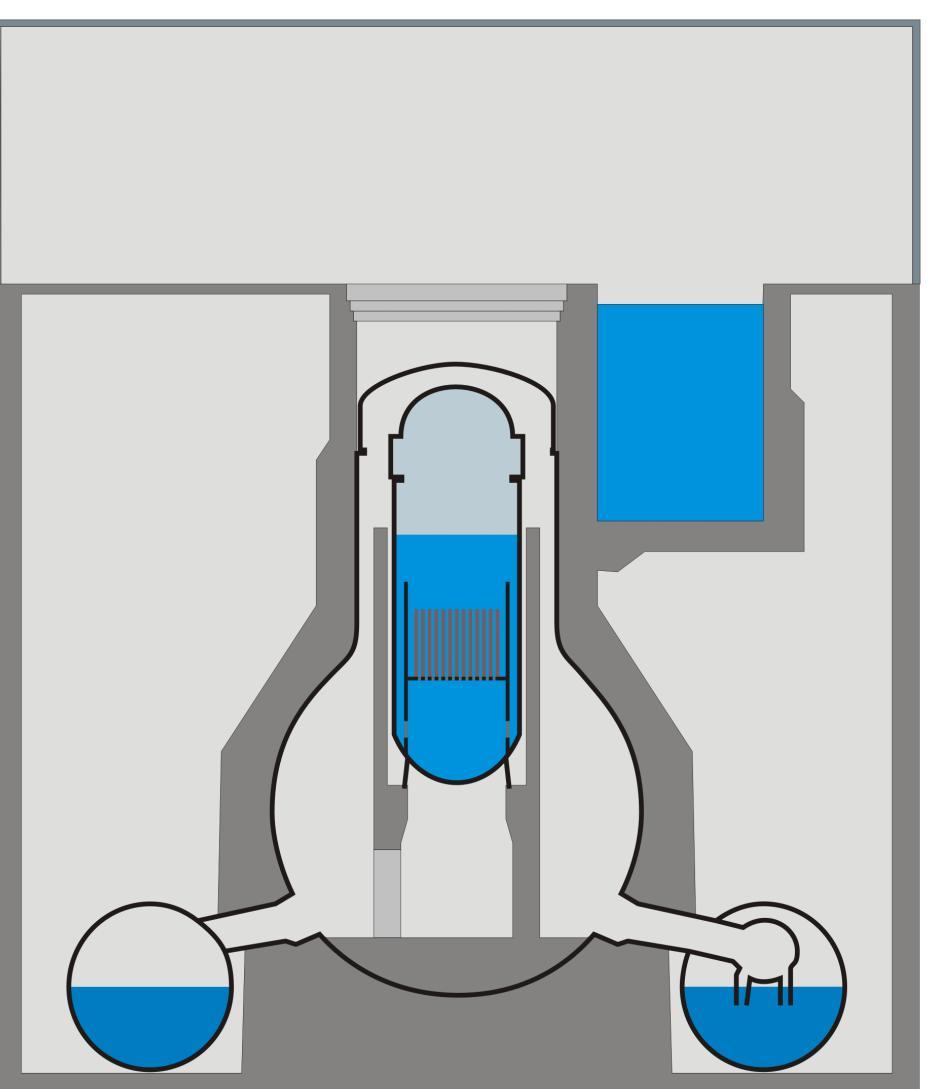
11.3. 15:41 Tsunami hits the plant

- Plant Design for Tsunami height of up to 6.5m
- Actual Tsunami height >7m
- Flooding of
 - Diesel Generators and/or
 - Essential service water building cooling the generators
- Station Blackout
 - Common cause failure of the power supply
 - Only Batteries are still available
 - Failure of all but one Emergency core cooling systems

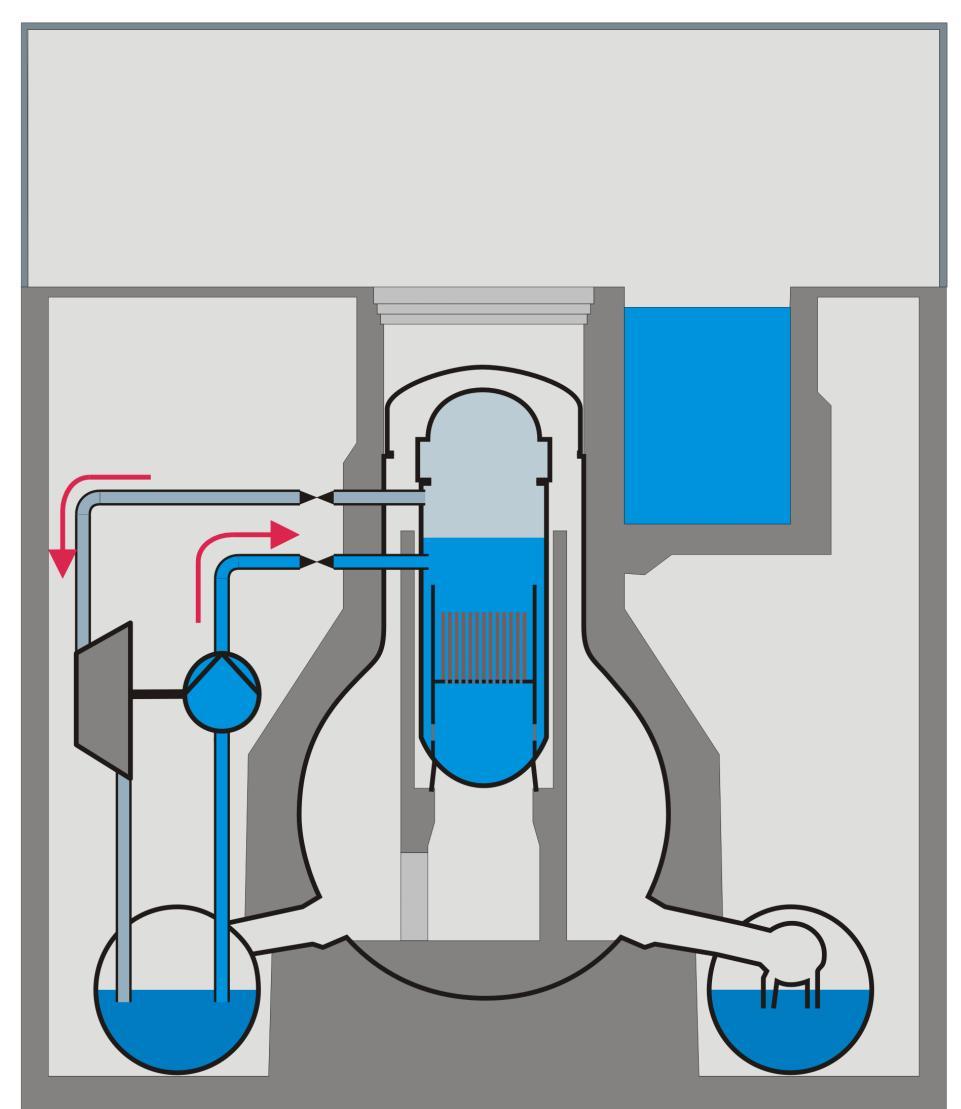
Reactor Core Isolation Pump still available

- Steam from the Reactor drives a Turbine
- Steam gets condensed in the Wet-Well
- Turbine drives a Pump
- Water from the Wet-Well gets pumped in Reactor
- Necessary:
 - Battery power
 - Temperature in the wet-well must be below 100°C
- As there is no heat removal from the building, the Core isolation pump cant work infinitely

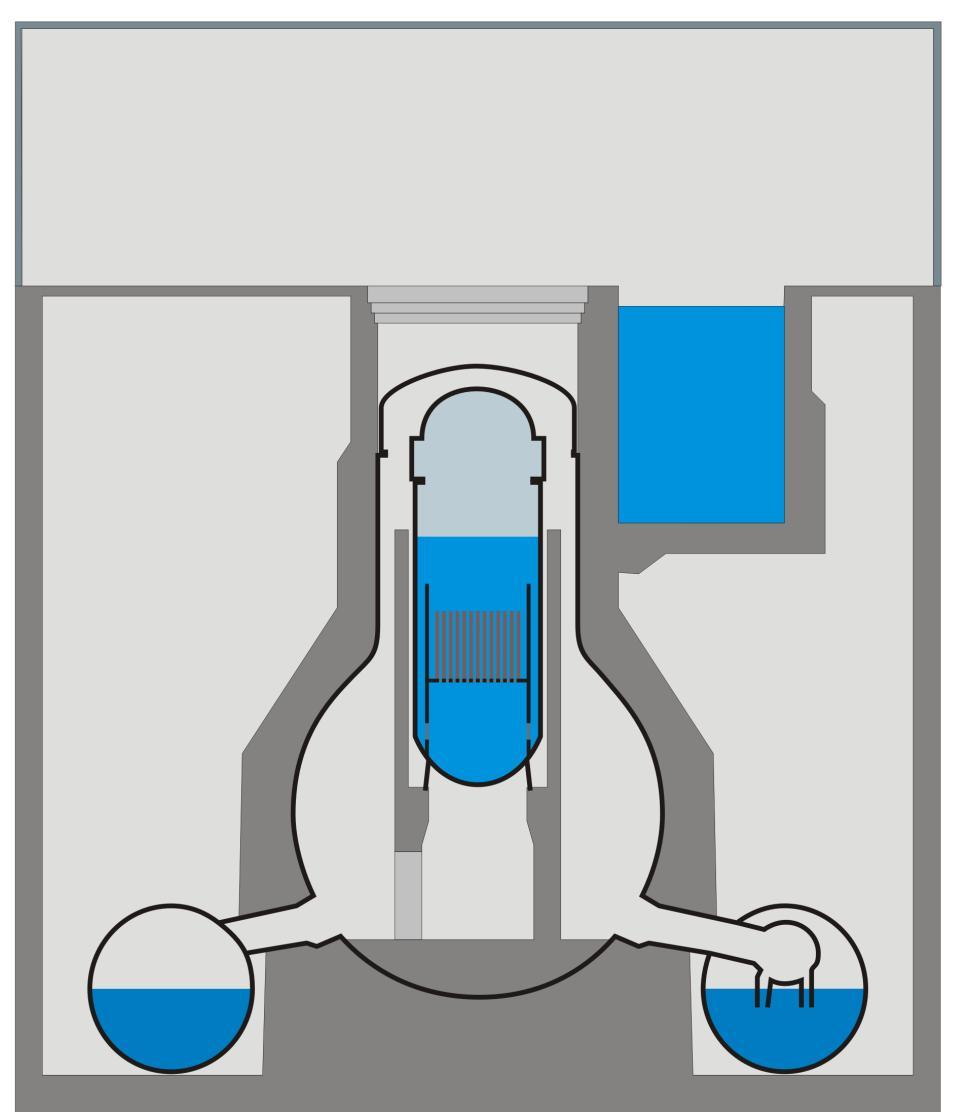
Reactor Isolation pump stops

- 11.3. 16:36 in Unit 1 (Batteries empty)
- 14.3. 13:25 in Unit 2 (Pump failure)
- 13.3. 2:44 in Unit 3 (Batteries empty)
- Decay Heat produces still steam in Reactor pressure Vessel
 - Pressure rising
- Opening the steam relieve valves
 Discharge Steam into the Wet-Well
- Descending of the Liquid Level in the Reactor pressure vessel

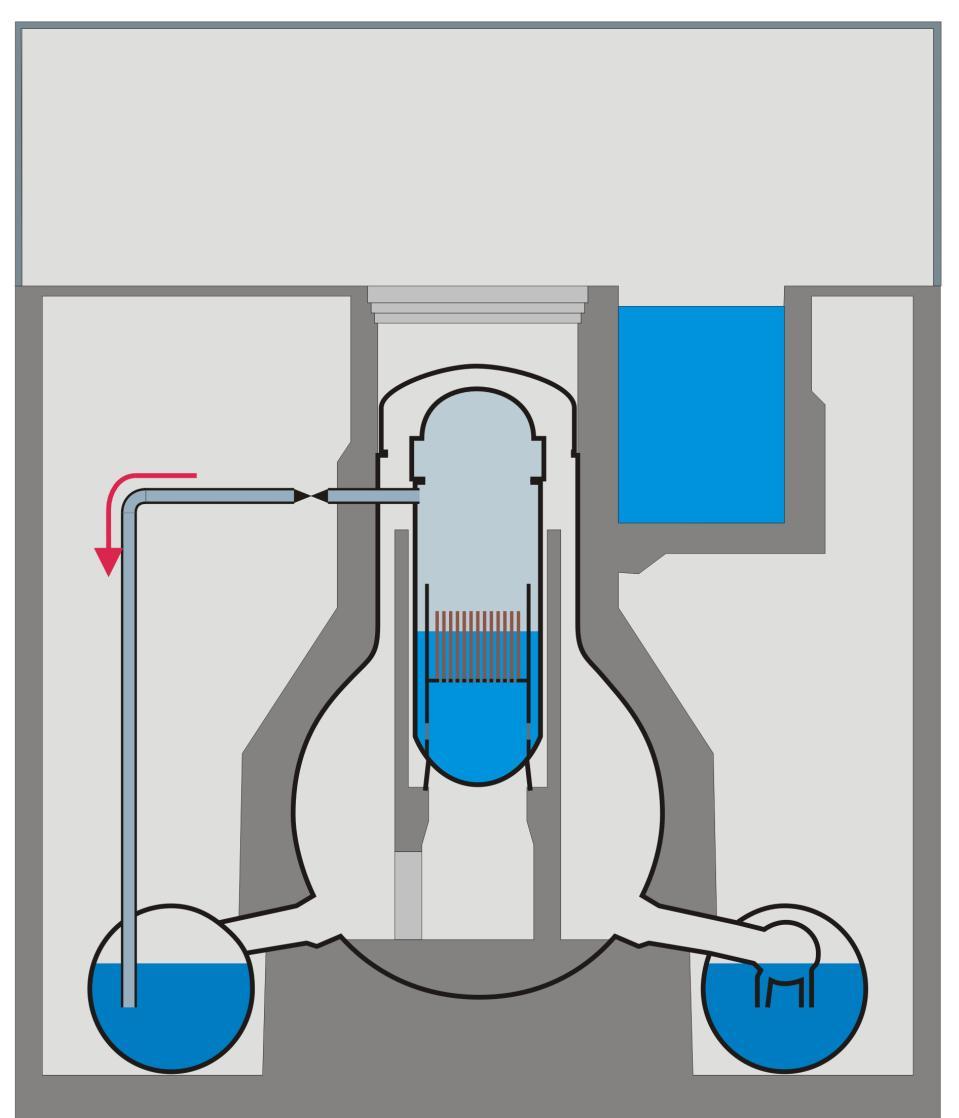
- Measured, and here referenced Liquid level is the collapsed level. The actual liquid level lies higher due to the steam bubbles in the liquid
- ~50% of the core exposed
 - Cladding temperatures rise, but still no significant core damage
- ~2/3 of the core exposed
 - Cladding temperature exceeds ~900°C
 - Balooning / Breaking of the cladding
 - Release of fission products form the fuel rod gaps

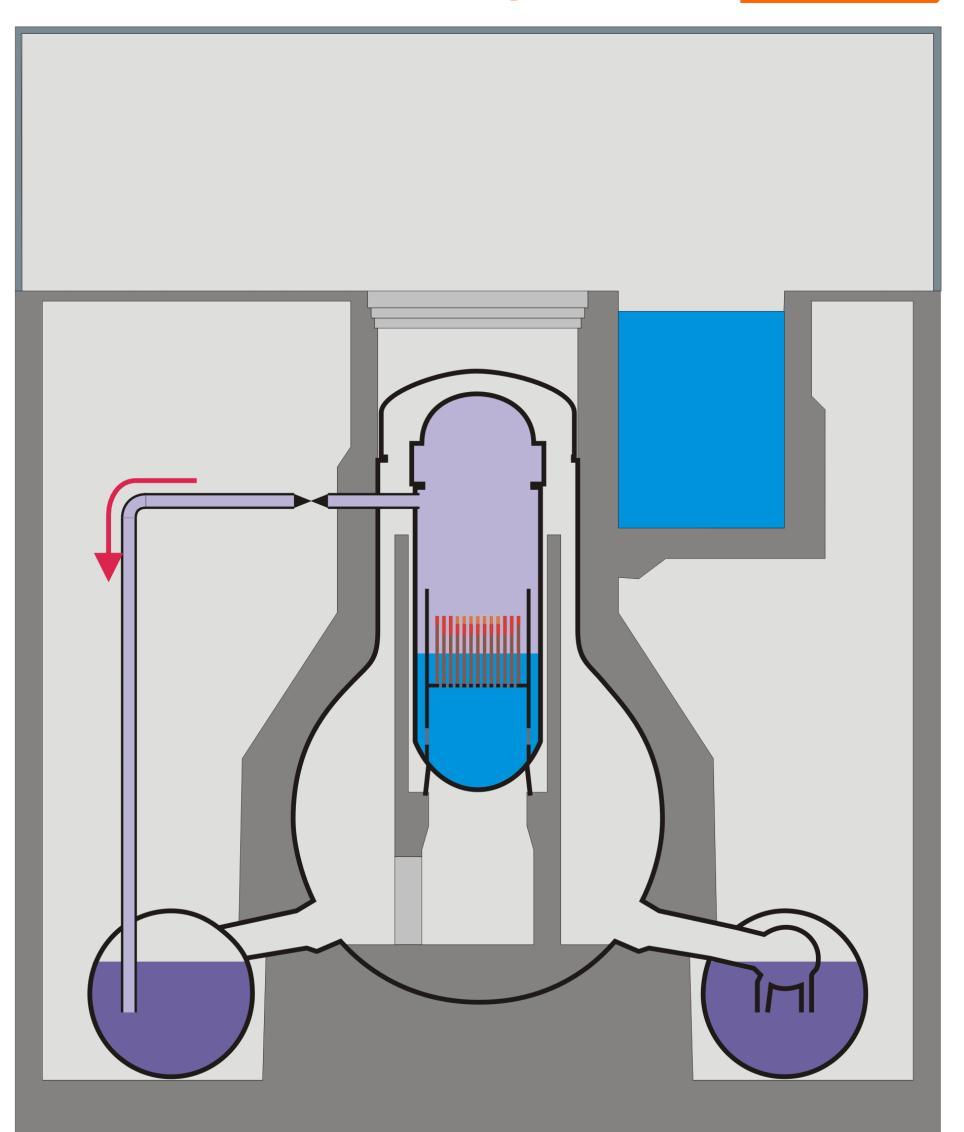
~3/4 of the core exposed

- Cladding exceeds ~1200°C
- Zirconium in the cladding starts to burn under Steam atmosphere
- Zr + 2H₂0 ->ZrO₂ + 2H₂
- Exothermal reaction further heats the core
- Generation of hydrogen
 - Unit 1: 300-600kg
 - Unit 2/3: 300-1000kg
- Hydrogen gets pushed via the wet-well, the wet-well vacuum breakers into the dry-well

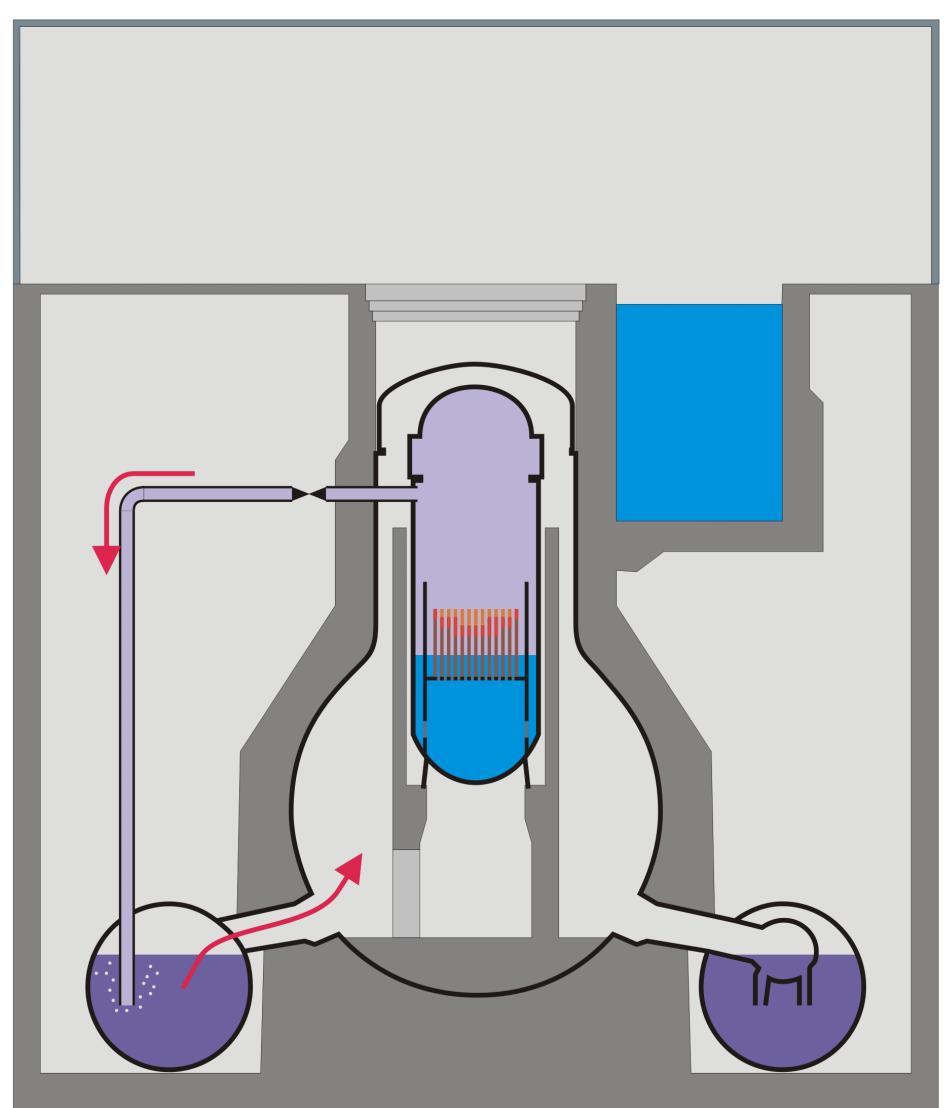
at ~1800°C

- Melting of the Cladding
- Melting of the steel structures
- ▶ at ~2500°C [Block 1,2]
 - Breaking of the fuel rods
 - debris bed inside the core
- ▶ at ~2700°C

- Melting of Uranium-Zirconium eutectics
- Restoration of the water supply stops accident in all 3 Units
 - Unit 1: 12.3. 20:20 (27h w.o. water)
 - Unit 2: 14.3. 20:33 (7h w.o. water)
 - Unit 3: 13.3. 9:38 (7h w.o. water)

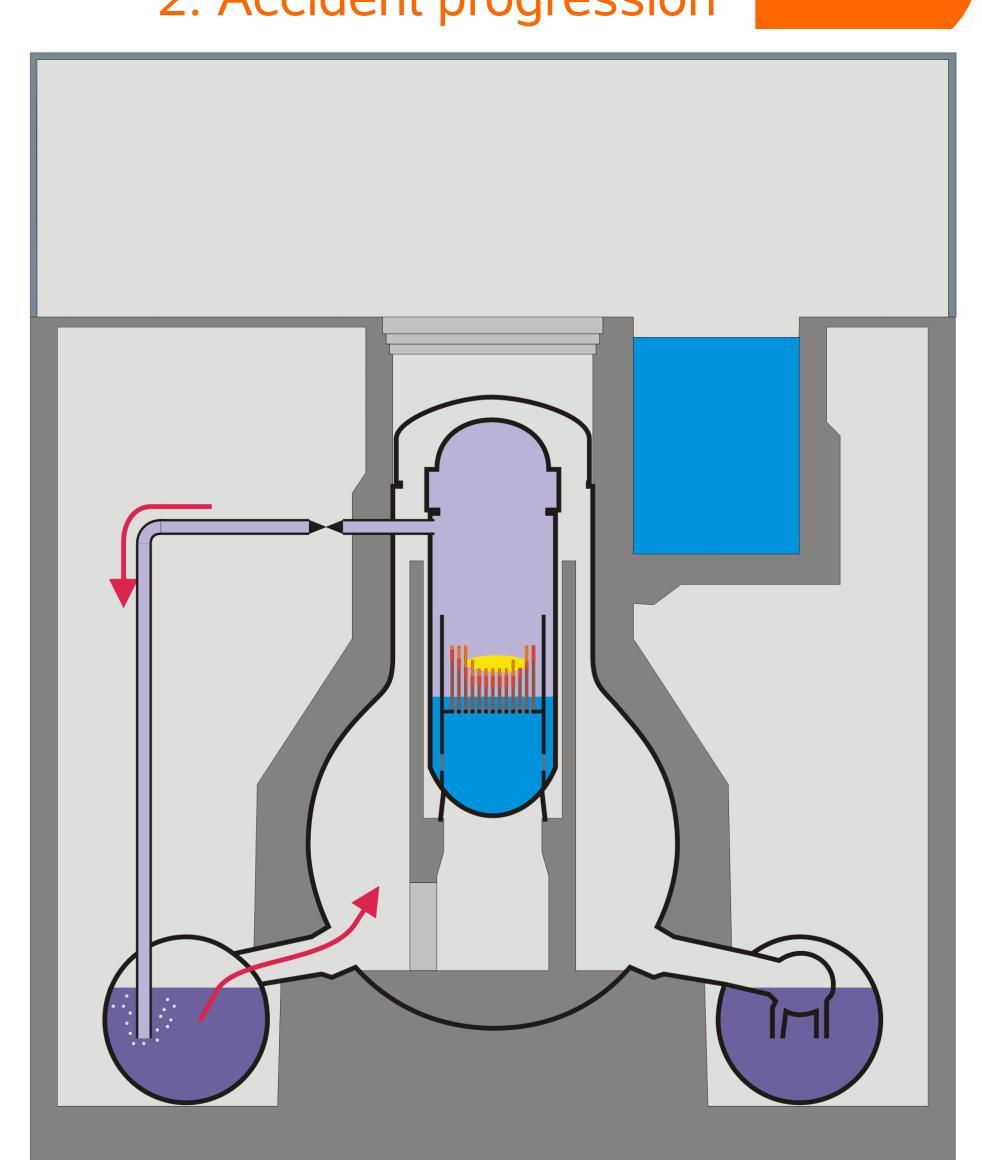
- Release of fission products during melt down
 - Xenon, Cesium, Iodine,...
 - Uranium/Plutonium remain in core
 - Fission products condensate to airborne Aerosols
- Discharge through valves into water of the condensation chamber
 - Pool scrubbing binds a fraction of Aerosols in the water
- Xenon and remaining aerosols enter the Dry-Well
 - Deposition of aerosols on surfaces further decontaminates air

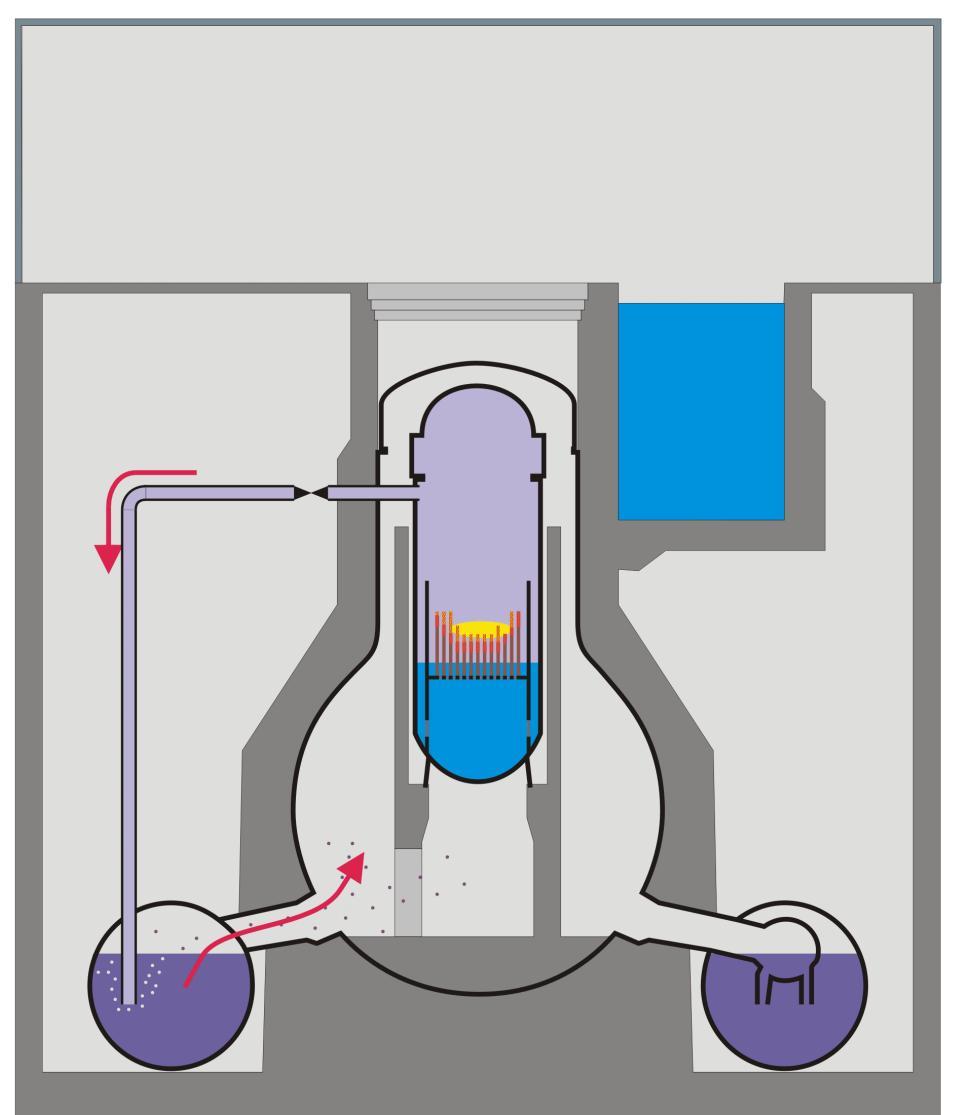
Containment

- Last barrier between Fission Products and Environment
- Wall thickness ~3cm
 - Design Pressure 4-5bar
- Actual pressure up to 8 bars
 - Normal inert gas filling (Nitrogen)
 - Hydrogen from core oxidation
 - Boiling condensation chamber (like a pressure cooker)
- Depressurization of the containment
 - + Unit 1: 12.3. 4:00
 - 🔶 Unit 2: 13.3 00:00
 - 🔶 Unit 3: 13.3. 8.41

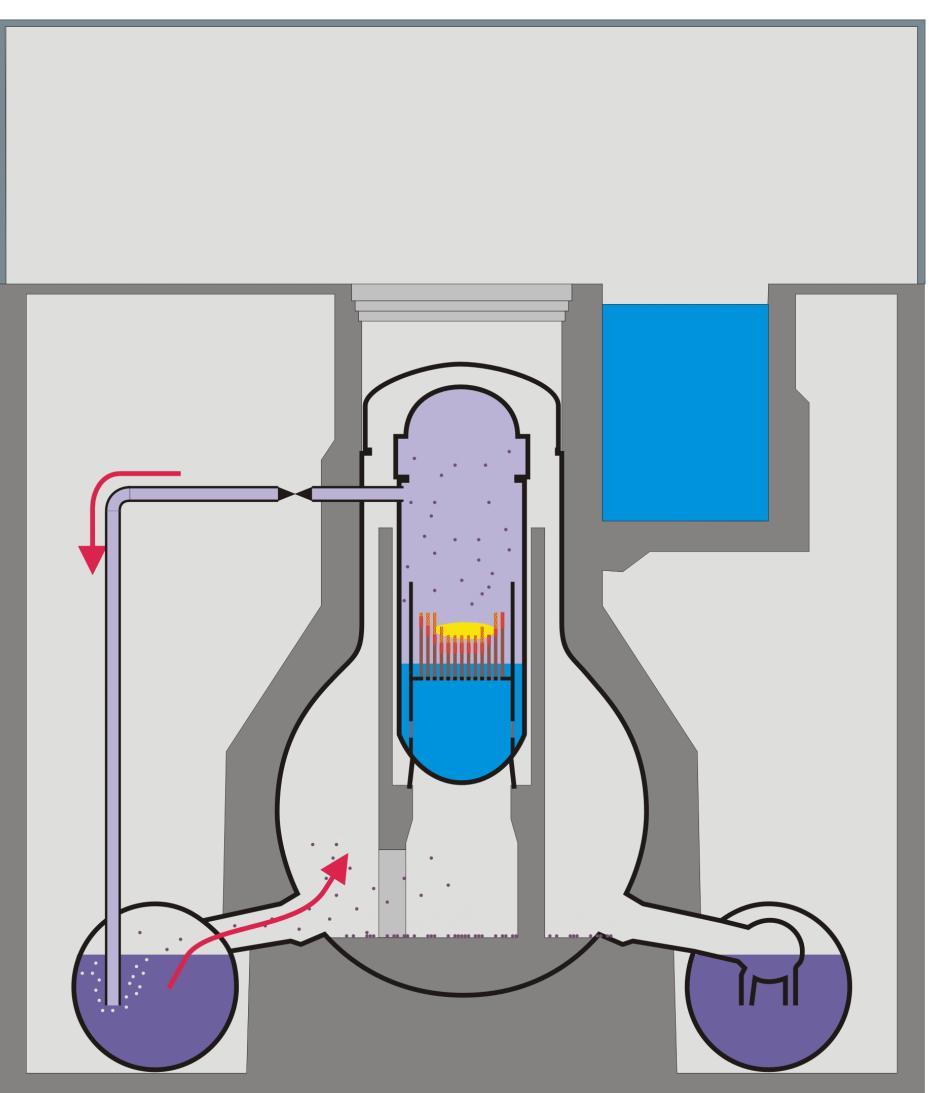
- Positive und negative Aspects of depressurizing the containment
 - Removes Energy from the Reactor building (only way left)
 - Reducing the pressure to ~4 bar
 - Release of small amounts of Aerosols (Iodine, Cesium ~0.1%)
 - Release of all noble gases
 - Release of Hydrogen
- Gas is released into the reactor service floor
 - Hydrogen is flammable

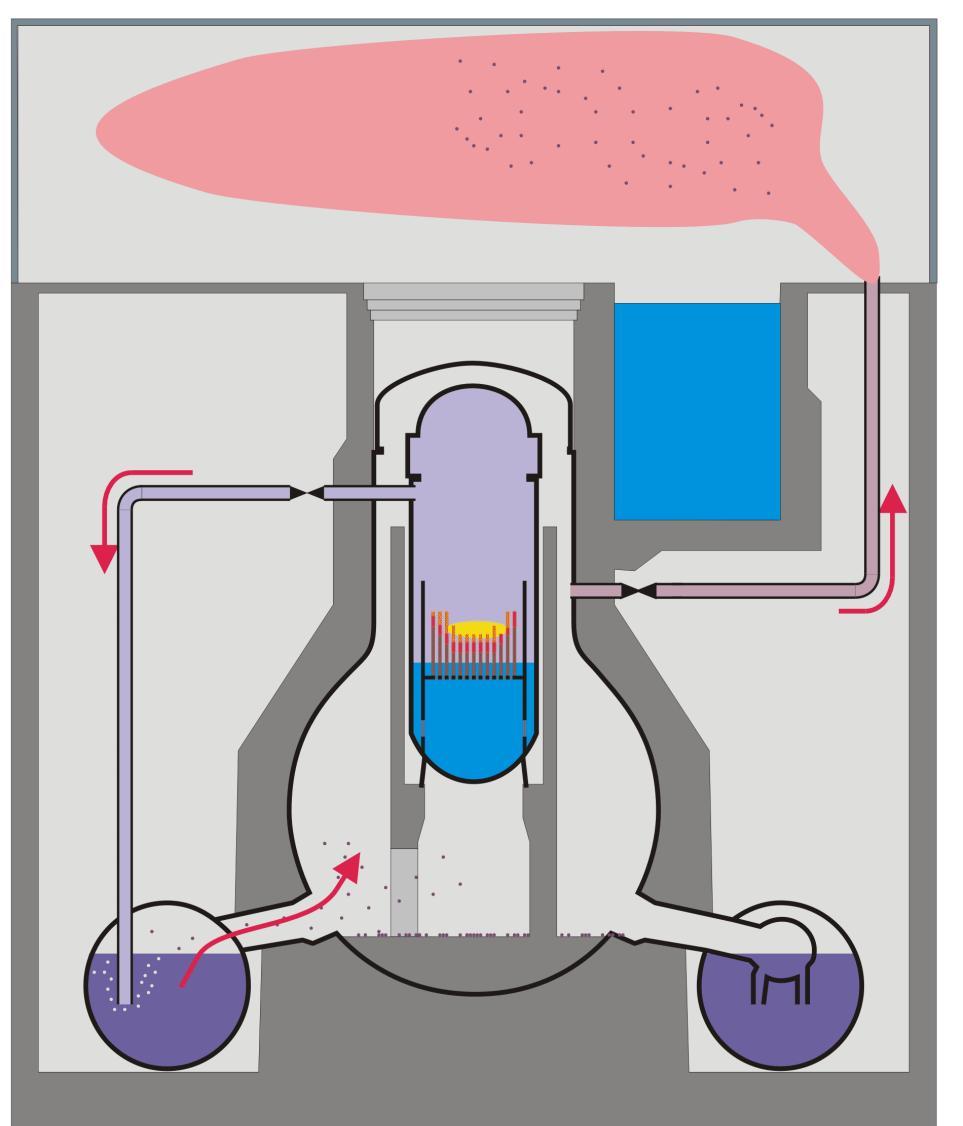
Unit 1 und 3

- Hydrogen burn inside the reactor service floor
- Destruction of the steel-frame roof
- Reinforced concrete reactor building seems undamaged
- Spectacular but minor safety relevant

- Hydrogen burn inside the reactor building
- Probably damage to the condensation chamber (highly contaminated water)
- Uncontrolled release of gas from the containment

No clear information's why Unit 2 behaved differently
