The Fukushima Daiichi Incident

Matthias Braun PEPA4-G, AREVA–NP GmbH Matthias.Braun@AREVA.com

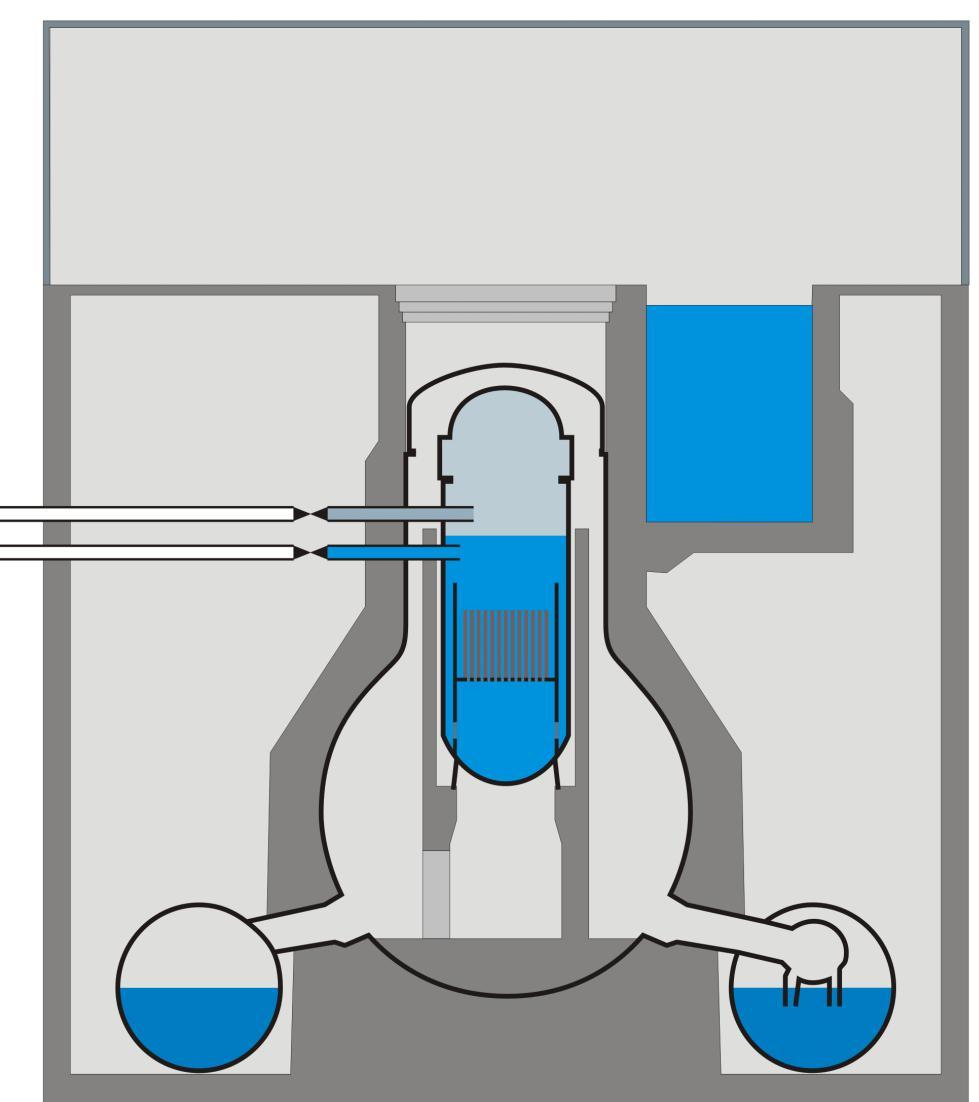
11.3. 15:41 Tsunami hits the plant

- Plant Design for Tsunami height of up to 6.5m
- Actual Tsunami height >7m
- Flooding of
 - Diesel Generators and/or
 - Essential service water building cooling the generators
- Station Blackout
 - Common cause failure of the power supply
 - Only Batteries are still available
 - Failure of all but one Emergency core cooling systems

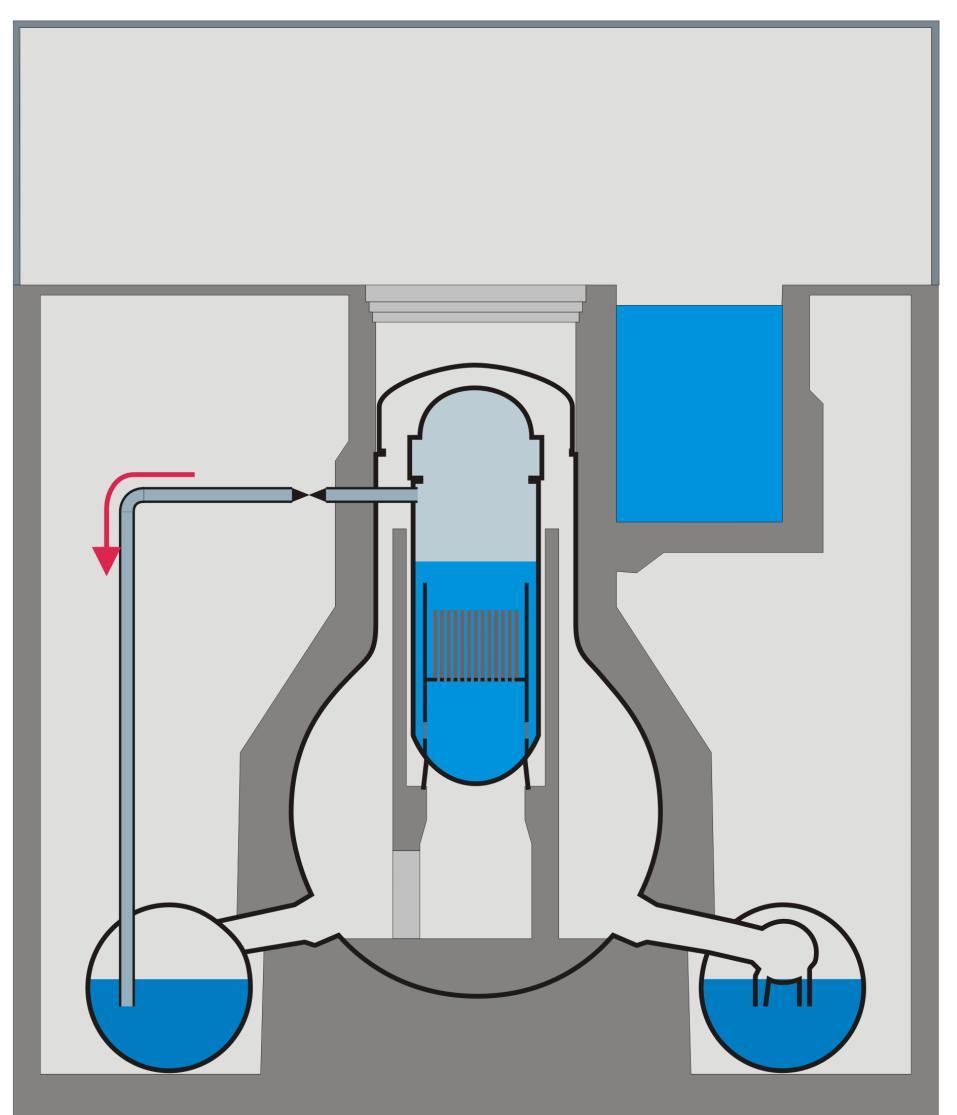
Reactor Isolation pump stops

- 11.3. 16:36 in Unit 1 (Batteries empty)
- 14.3. 13:25 in Unit 2 (Pump failure)
- 13.3. 2:44 in Unit 3 (Batteries empty)
- Decay Heat produces still steam in Reactor pressure Vessel
 - Pressure rising
- Opening the steam relieve valves
 Discharge Steam into the Wet-Well
- Descending of the Liquid Level in the Reactor pressure vessel

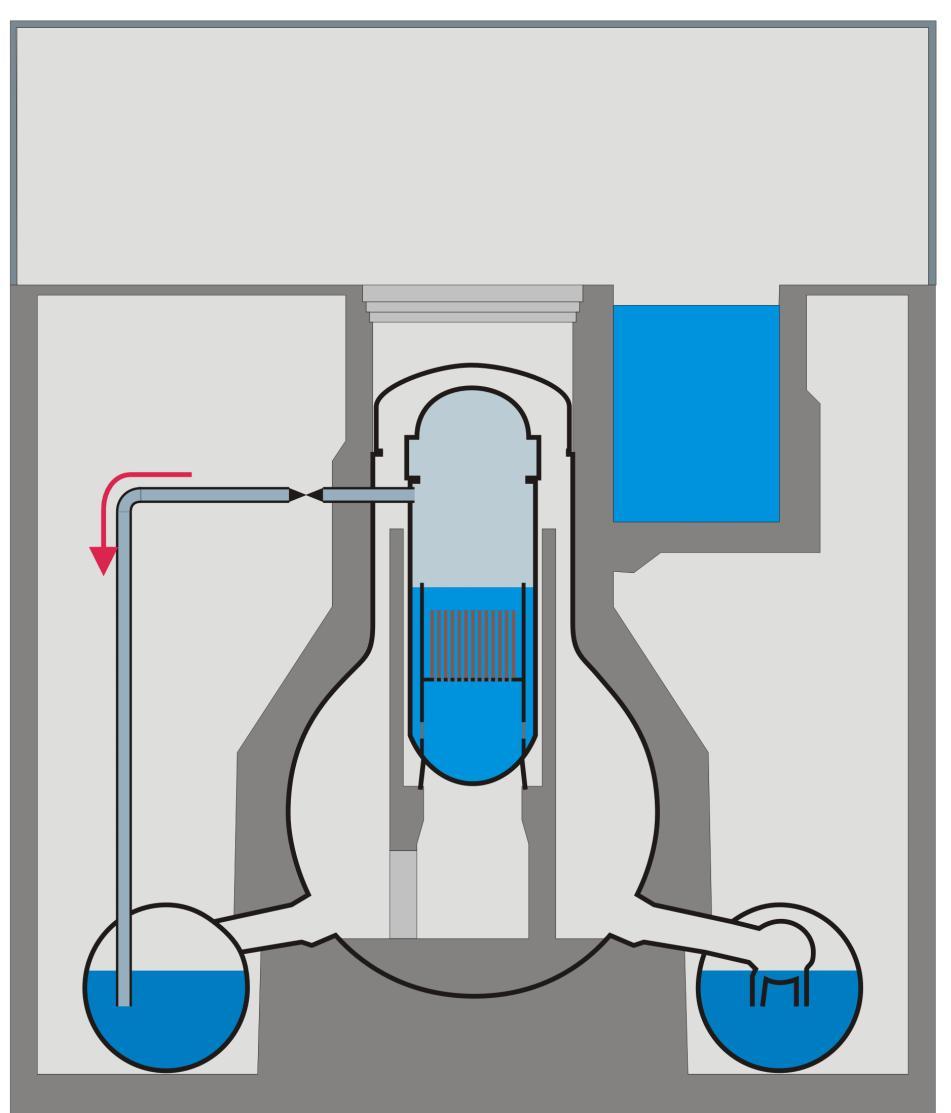
Reactor Isolation pump stops

- 11.3. 16:36 in Unit 1 (Batteries empty)
- 14.3. 13:25 in Unit 2 (Pump failure)
- 13.3. 2:44 in Unit 3 (Batteries empty)
- Decay Heat produces still steam in Reactor pressure Vessel
 - Pressure rising
- Opening the steam relieve valves
 Discharge Steam into the Wet-Well
- Descending of the Liquid Level in the Reactor pressure vessel

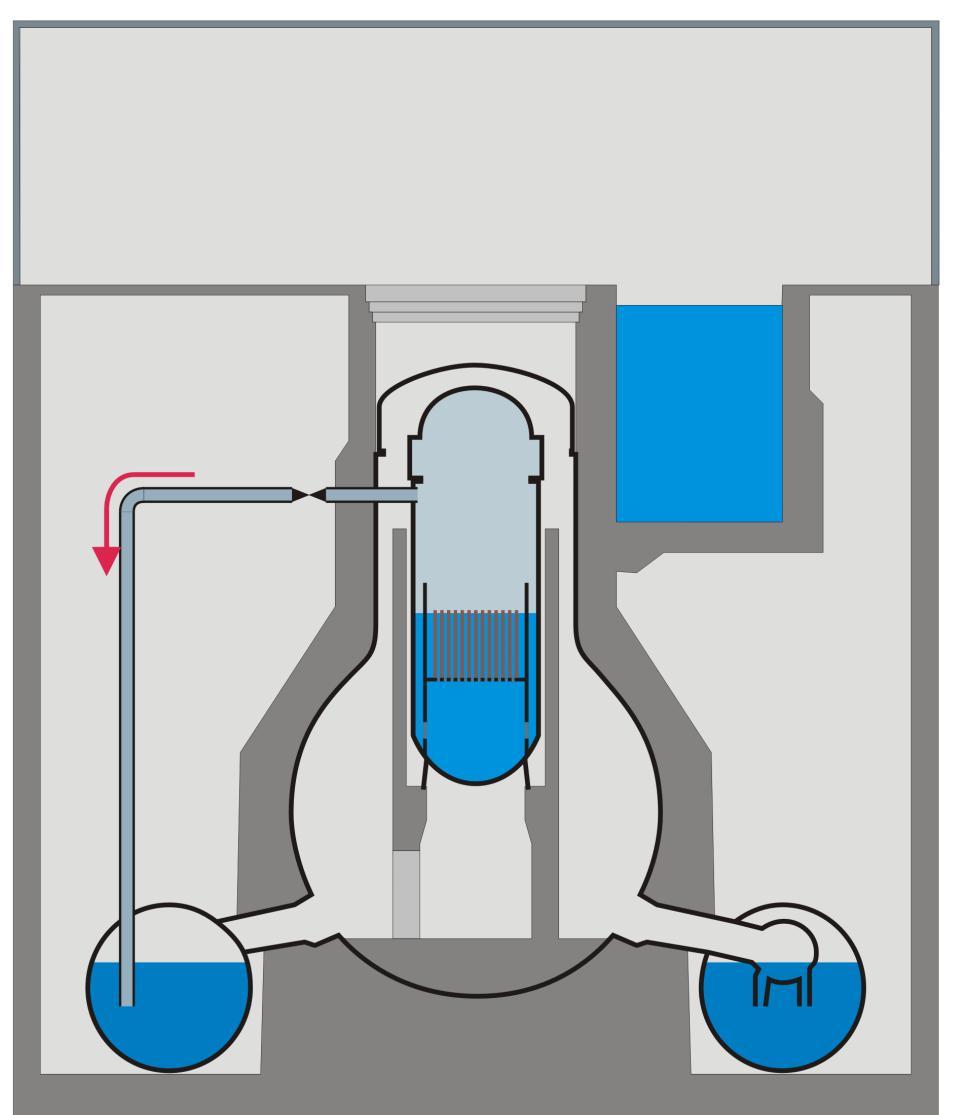
Reactor Isolation pump stops

- 11.3. 16:36 in Unit 1 (Batteries empty)
- 14.3. 13:25 in Unit 2 (Pump failure)
- 13.3. 2:44 in Unit 3 (Batteries empty)
- Decay Heat produces still steam in Reactor pressure Vessel
 - Pressure rising
- Opening the steam relieve valves
 Discharge Steam into the Wet-Well
- Descending of the Liquid Level in the Reactor pressure vessel
